Manhole Inspection Summary

Manhole # S35WW1002MH

Insp Date: 1/31/07 10:44 AM

Location Address: **332 TUNBRIDGE RD**

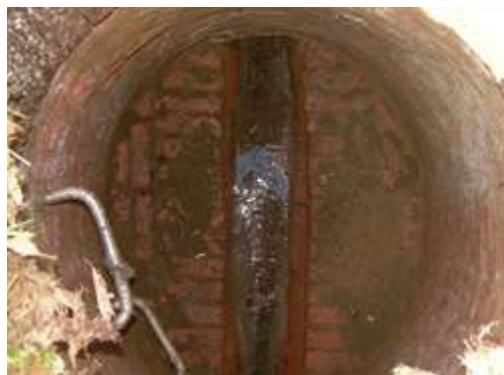
Top View

Evidence of surcharge - Bench debris.
Channel debris.

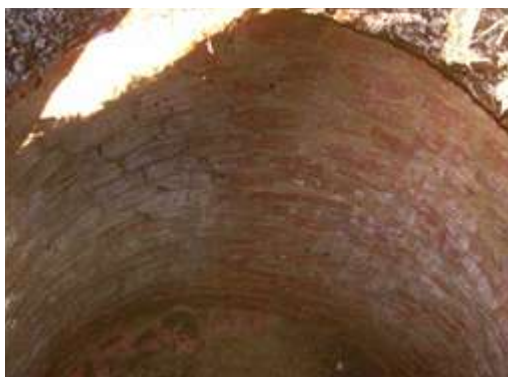
Defect

Frame leaks. Adjustment deterioration
and infiltration. Corbel and Barrel
infiltration - other side.

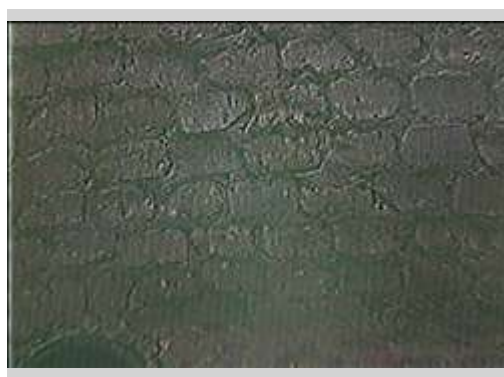
Defect

Barrel deterioration and infiltration.

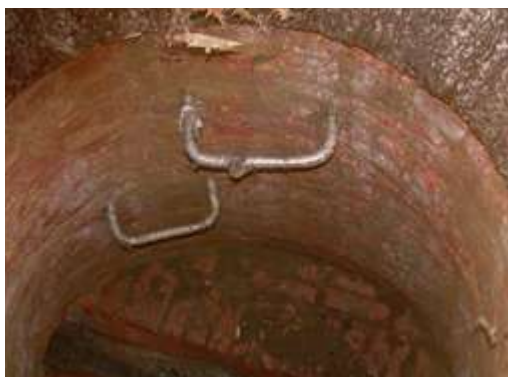
Defect

Frame leaks. Adjustment deterioration
and infiltration. Corbel and Barrel
infiltration.

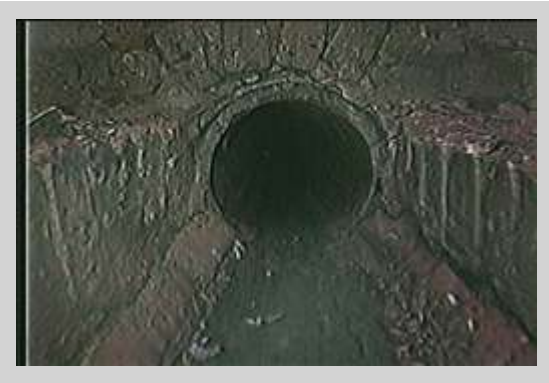
8 in. Circular Gravity Sewer Pipe Out @ 12 O'Clock

Barrel deterioration and infiltration. Channel deterioration.

Infiltration: **Evidence** Pipe Seal Cond: **Cracked**

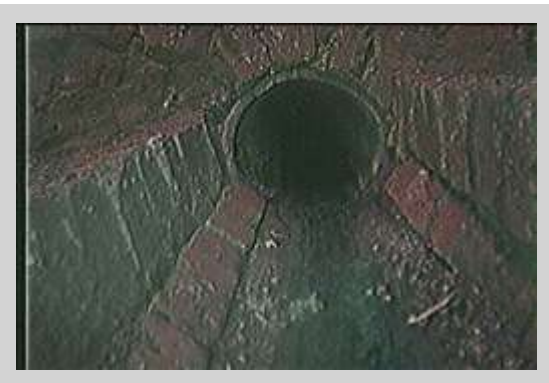
8 in. Circular Gravity Sewer Pipe In @ 6 O'Clock

Barrel deterioration and infiltration. Channel deterioration.

Infiltration: **Evidence** Pipe Seal Cond: **Cracked**
